Animal Enhancement Activity –ANM18- Retrofit Watering Facility for Wildlife Escape

Indiana CSP Enhancement Supplemental Information

ANM18 - Retrofit Watering Facility for Wildlife Escape:

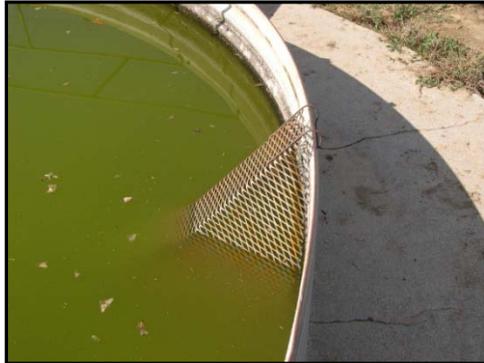
Retrofit existing watering facilities (troughs, tanks, etc.) to allow for the escape of wildlife that becomes trapped while trying to drink.

1. Extend into the water and meet the inside wall of the watering facility
2. Reach to the bottom of the watering facility
3. Be firmly secured to the rim of the watering facility so as not to be displaced by livestock
4. Be built of graspable, long-lasting materials, such as painted or coated metal grating, roughened fiberglass, concrete, rock and mortar, or high-strength plastic composites.
5. Have a slope no steeper than 45 degrees
6. Be located to cause minimal interference with livestock drinking
7. One structure for every 30 linear feet of watering facility edge.
